McCombie Smith Architects
12 Church Lane . Greetham . Rutland . LE15 7NF
Tel 01572 812808 Fax 01572 812466

Greetham Church
Estimated Form of Church
1200 to 1250

628/12/S10

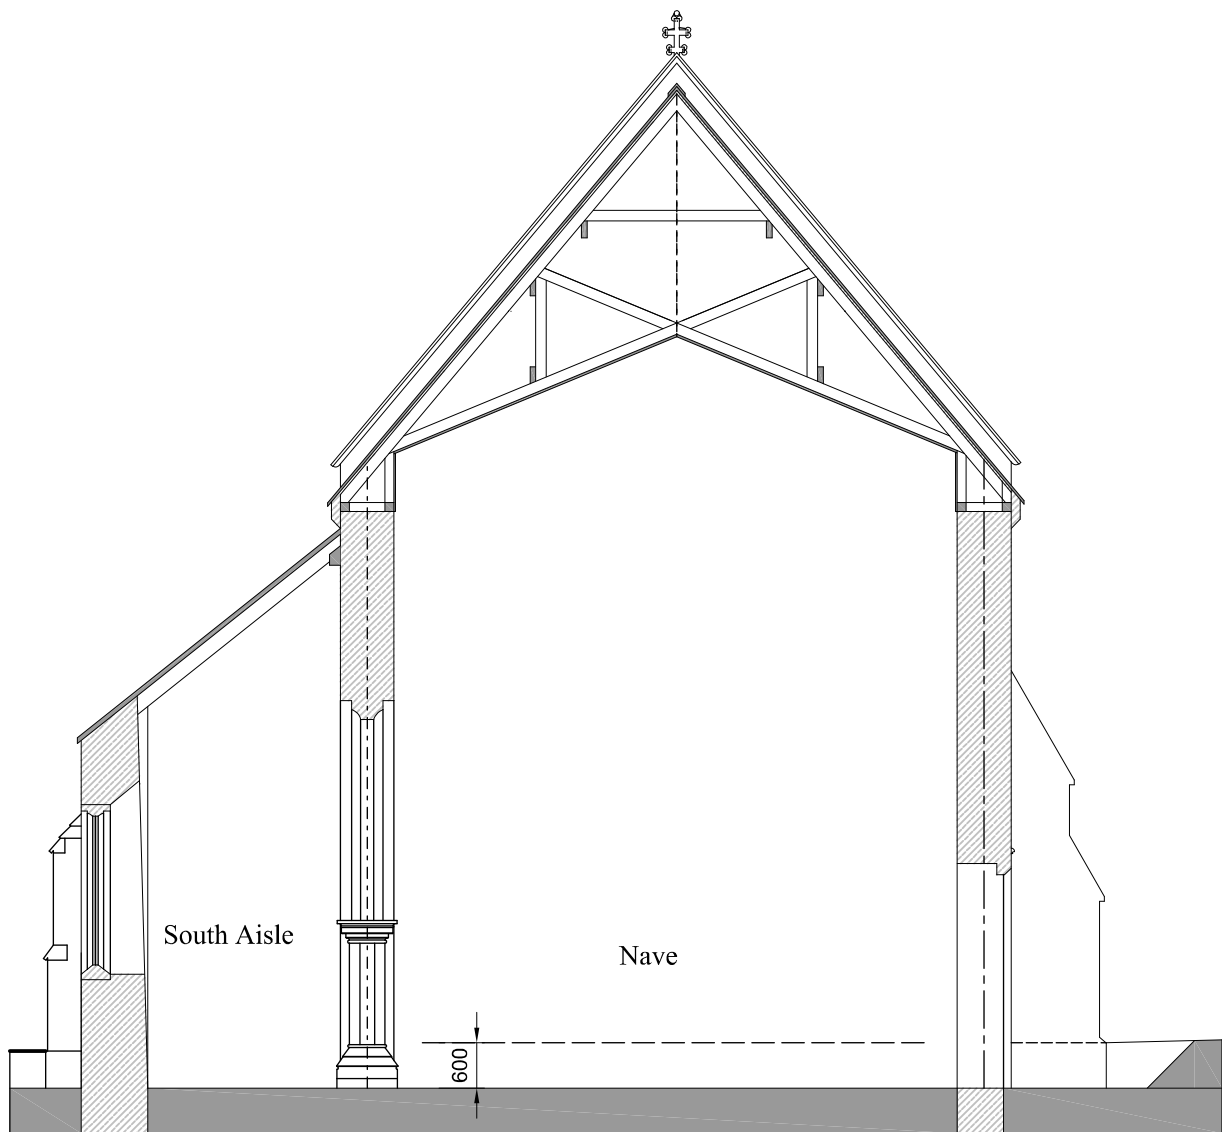
Cross Section B - Looking West showing Nave, South Aisle, & North door.

The roof structure of the nave can only be guessed at for it was replaced in the 14th century. I have shown a pitched roof supported on a timber structure of scissor trusses which were fashionable in Early English roofs, thus forming a lower internal ceiling of a lower pitch. This format is suggested by the evidence of stone string courses on the East Elevation of the tower. The junction between the roof structure and the head of the eaves walls shows a form of framing known as ashlar, also in use at about this time. The South Aisle roof is estimated, the resultant pitch being less than the minimum 50 degrees thought advisable for Collyweston slate roofing. The use of lead roof cladding did not come in until the next century, and so it is assumed that this roof was also clad in Collyweston slates, possible of greater size than usual. This roof may possibly have failed, which may have lead to it's replacement later.

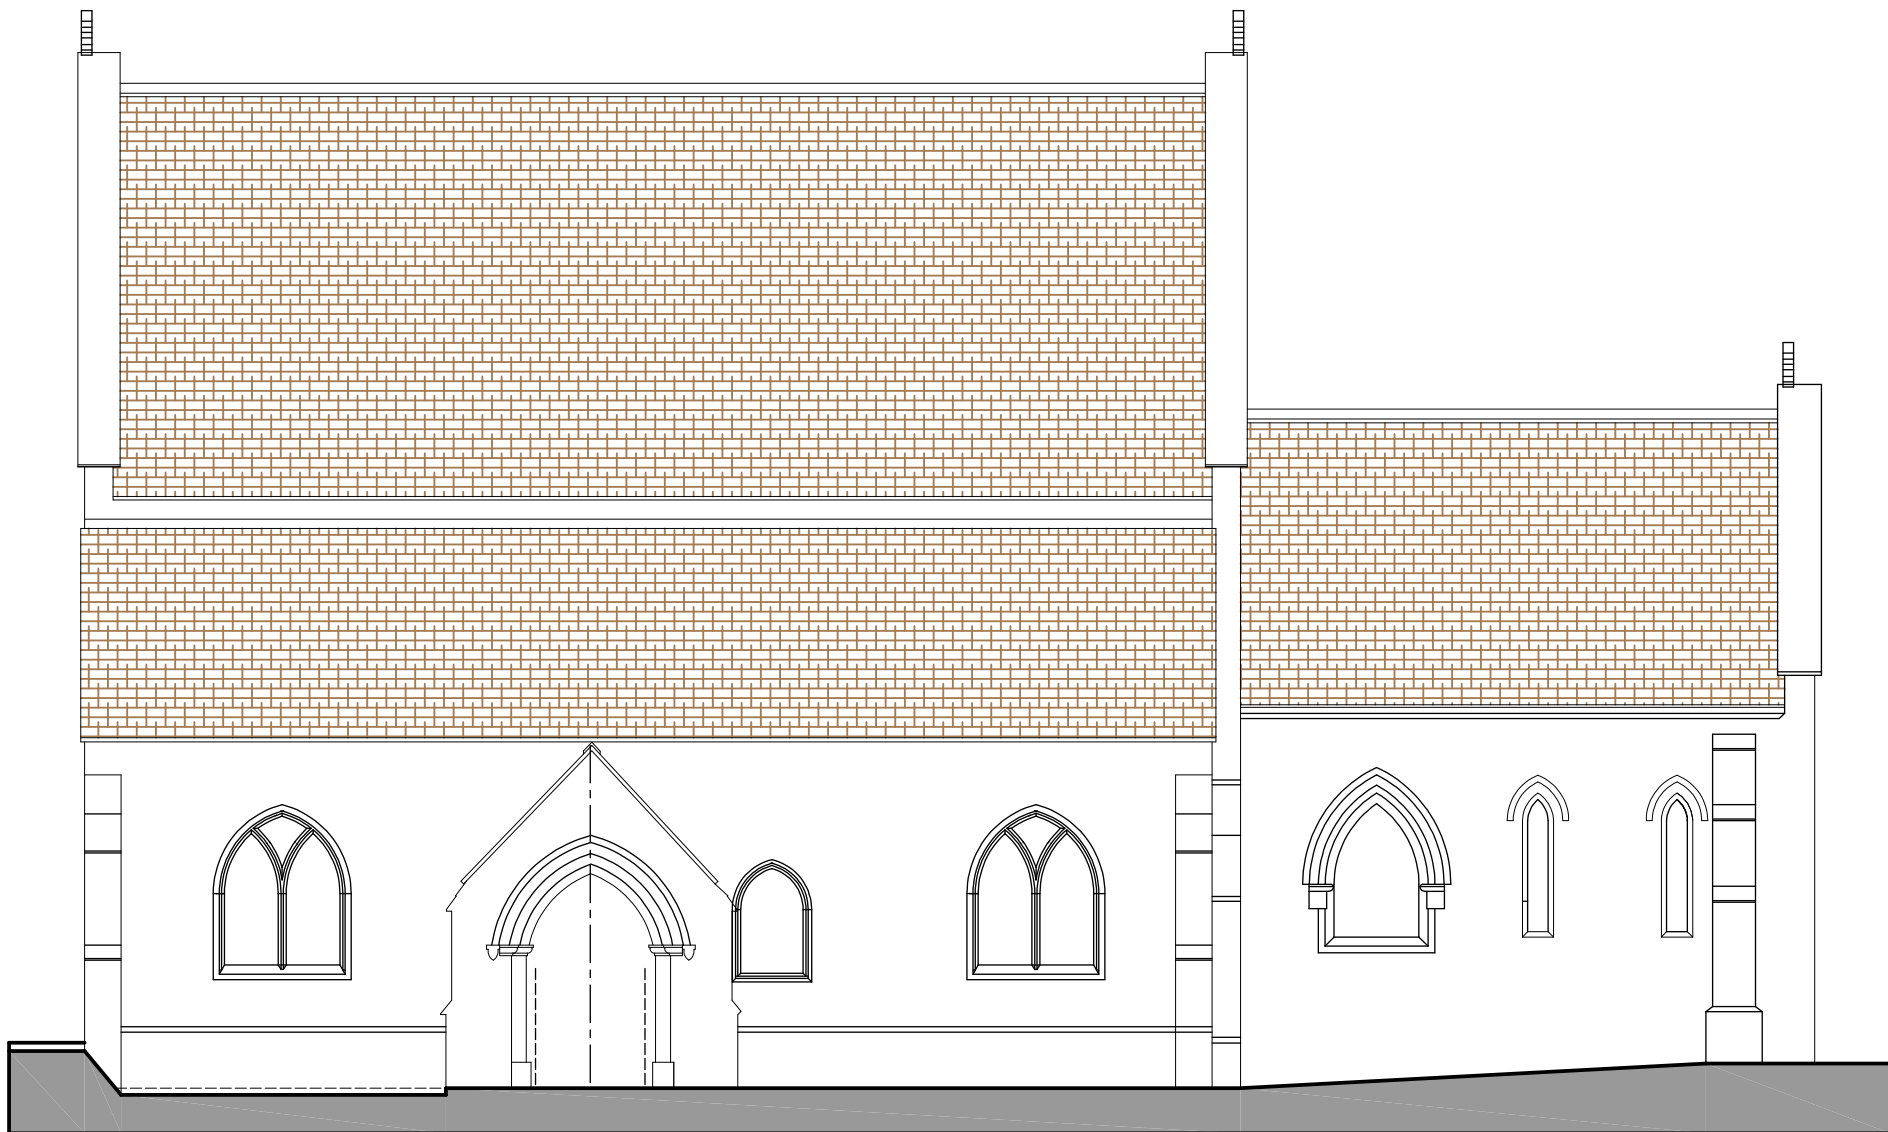
South Elevation

The three windows in the South wall of the South Aisle are derived from evidence of stone arches on the inside, the double lancet window on the West end being derived from such evidence and then copied symetrically at the Eastern end in the wall which extends the aisle to the end of the nave. This wall is estimated, having been removed in the 18th Century and replaced by the quasi-transept which now holds the organ. The smaller, central, pointed arch window in the middle is estimated from internal evidence. The existing lancet window in the West gable of the South aisle is removed, as records indicate that this was inserted during the Victorian works of 1897, ostensibly to replace an existing lancet in poor condition, as was the whole wall which was re-built at that time. Consequently, although lancets may have existed, none are shown here for lack of evidence.

The Chancel East window form is based on an early Victorian water colour showing a trabeated window head which was later replaced by a Victorian pointed arch with stone tracery. The only windows which survive from this Early English period are the two lancet windows in the South wall of the Chancel, while the third shown in the South wall of the Chancel is an estimation derived from a stone capital and the segment of an arch set in the existing South wall. The presence of a capital implies a door rather than a window, but on drawing an example it was thought so high that it looked wrong; however it may have been a doorway on the South side of the Chancel. No windows are shown in the North walls or the West gable, for the simple reason that no evidence exists of them, all three walls having been replaced or covered by later works.

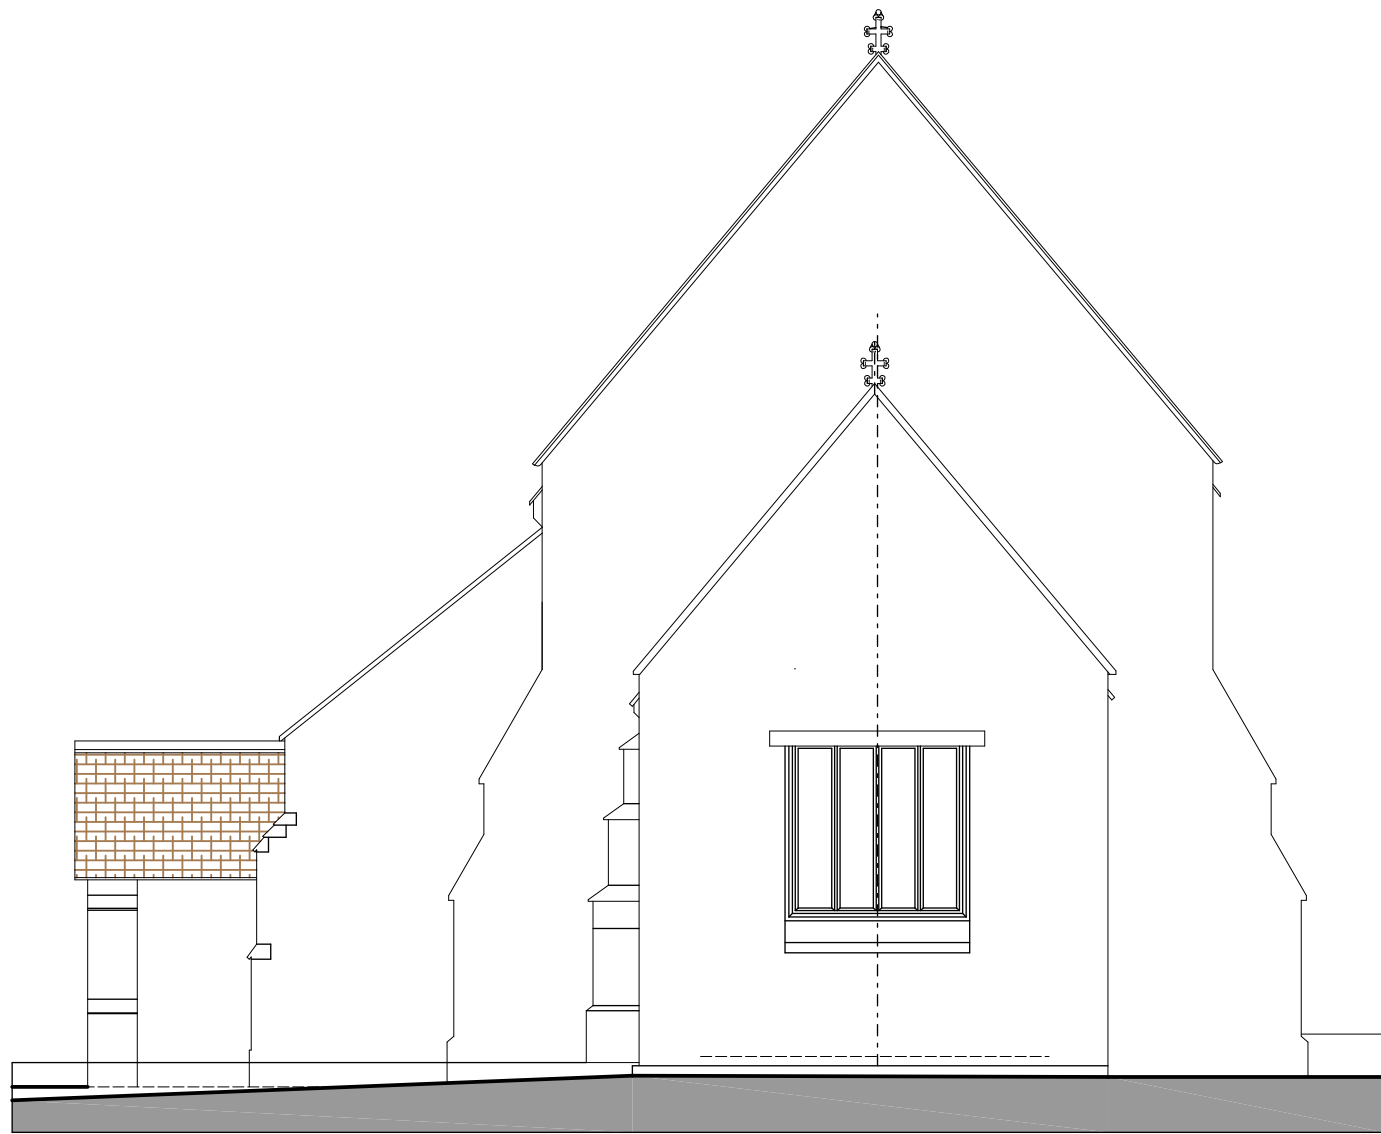
East Elevation

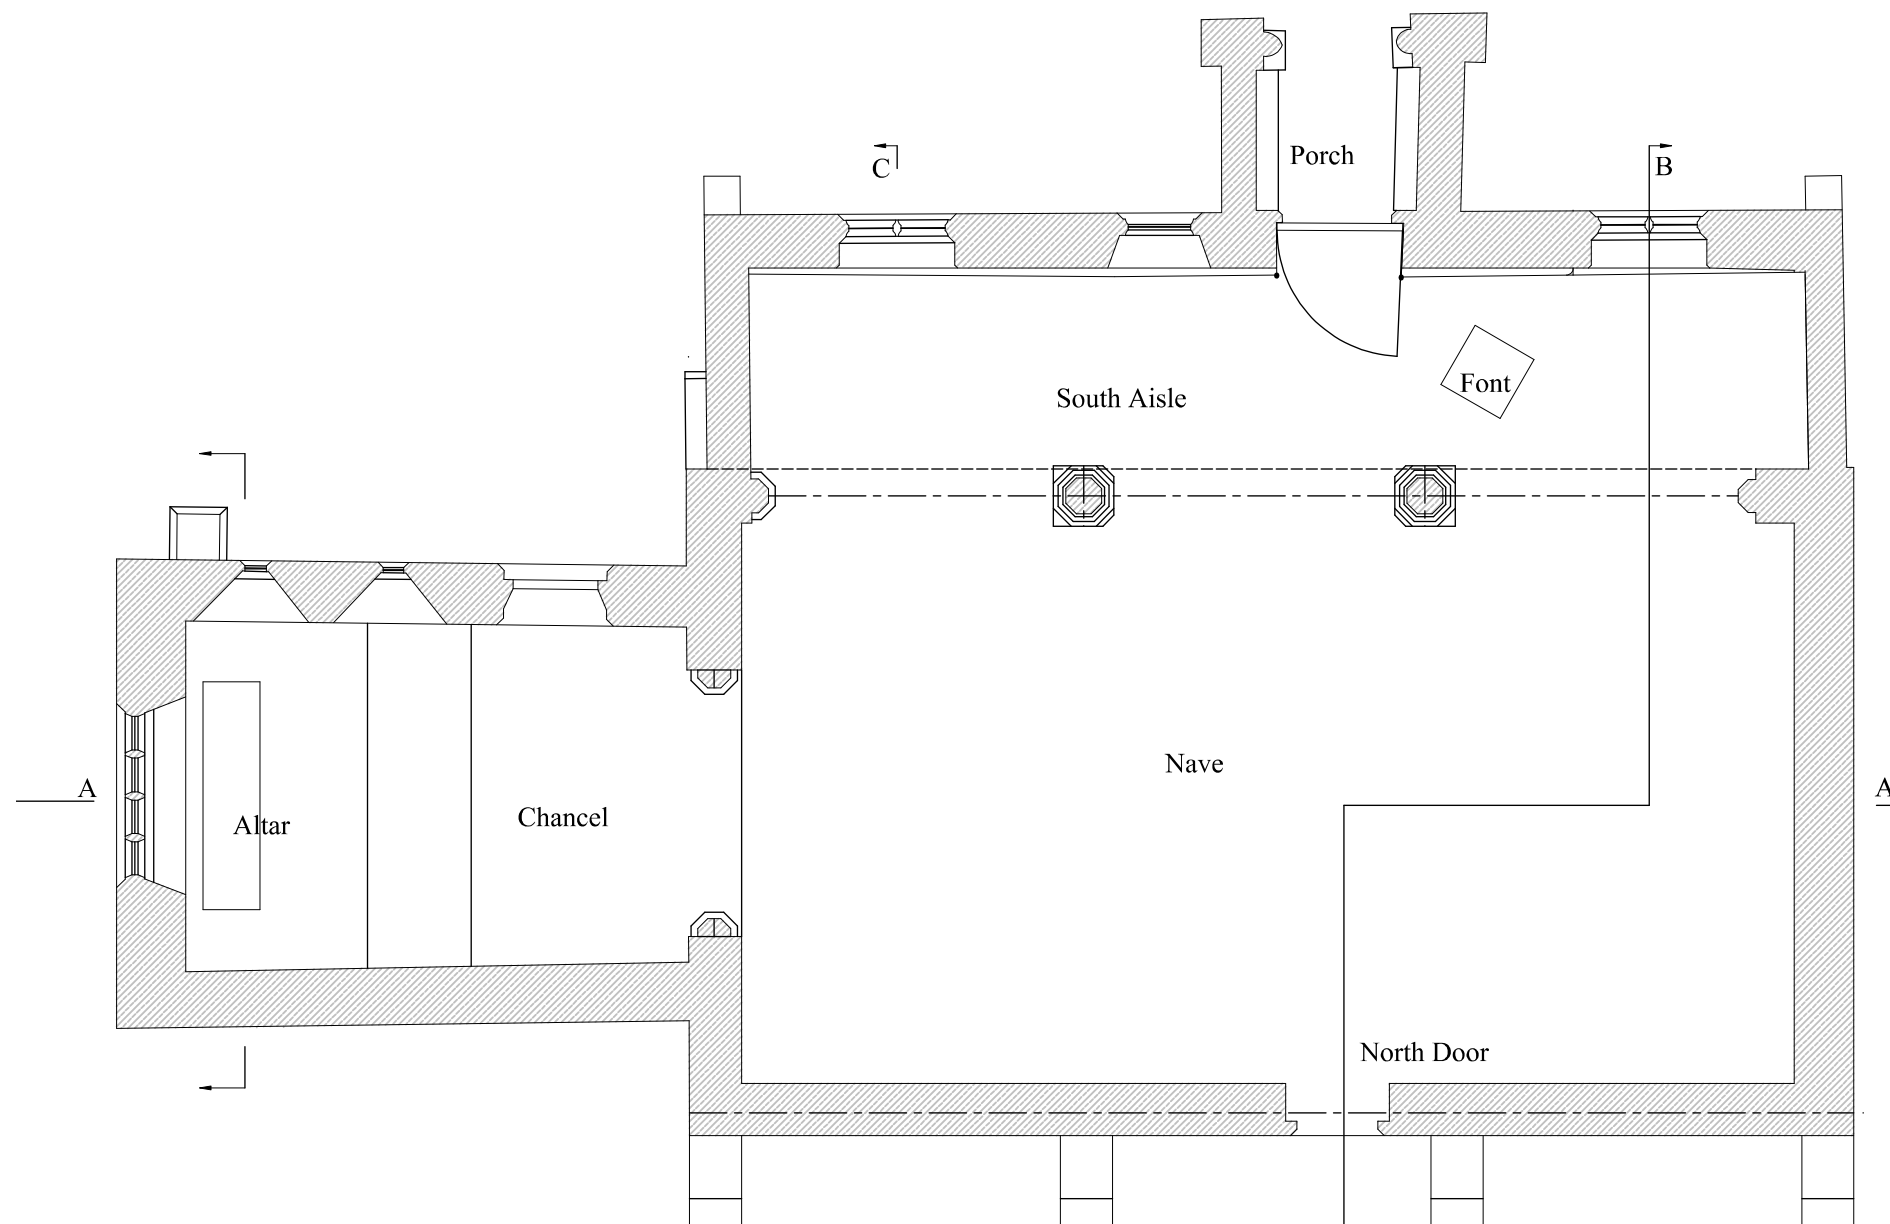
Ground Floor Plan

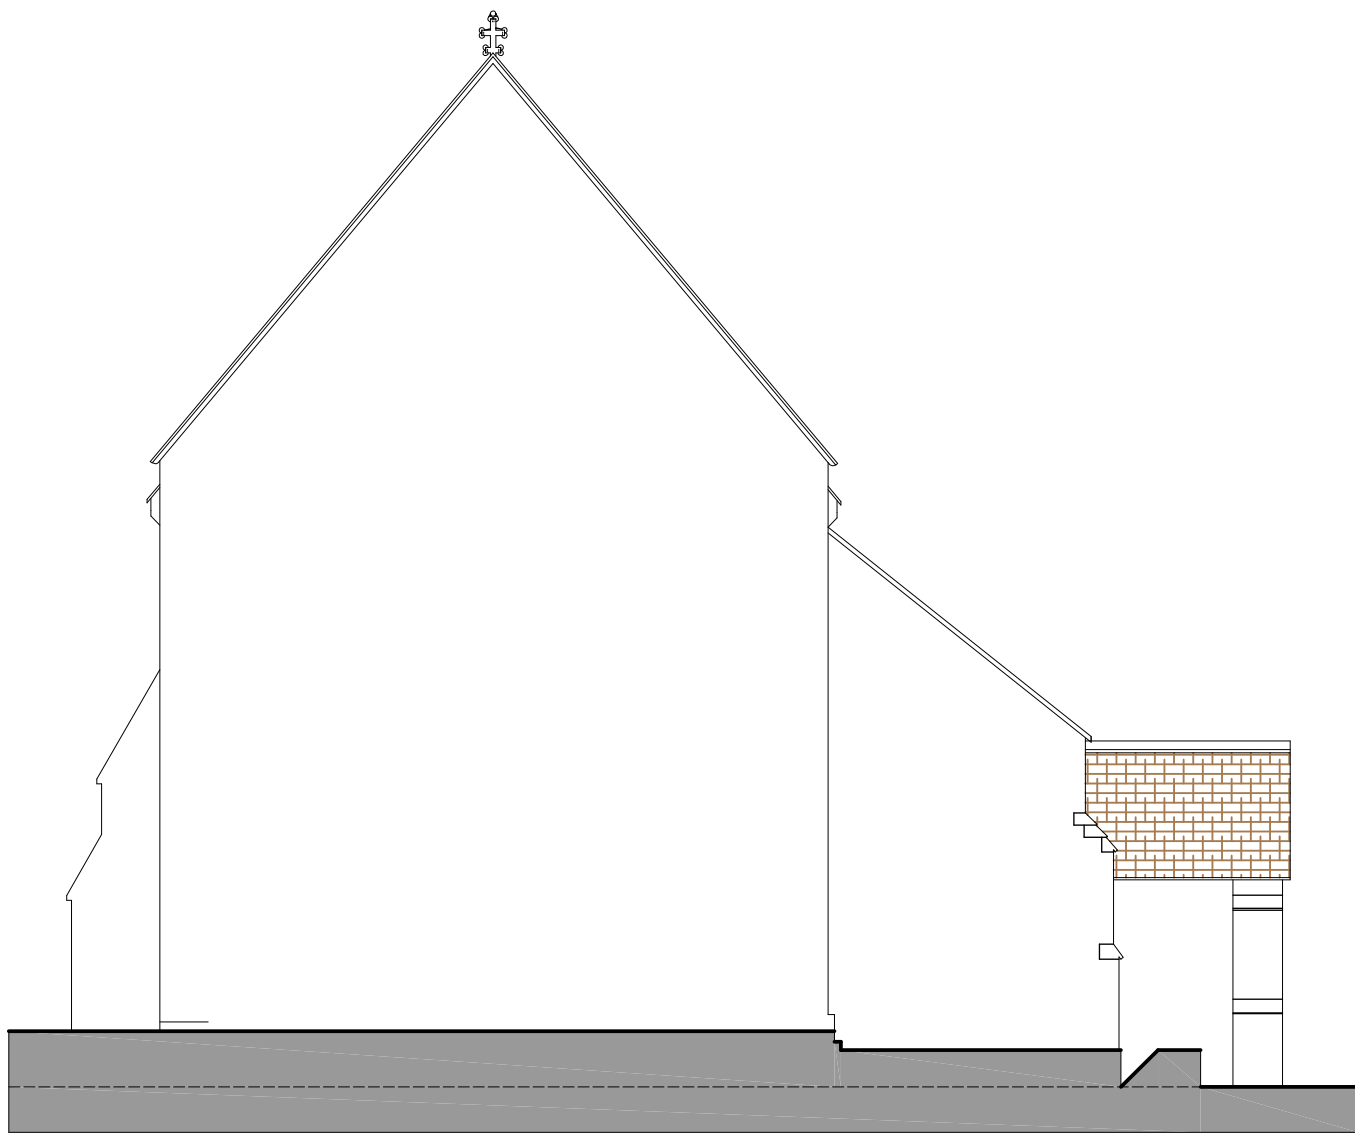
West Elevation
